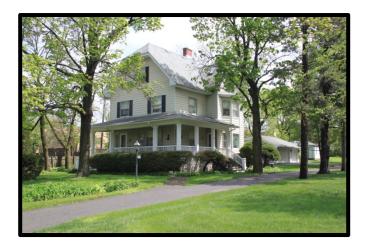
Condition: Excellent

Integrity: Good

Re-sided; windows replaced; shutters added

Architectural Style: Queen Anne

Roof Type: Cross gable Materials: Asphalt shingle

Roof Ornamentation: Jerkinhead clipped gables

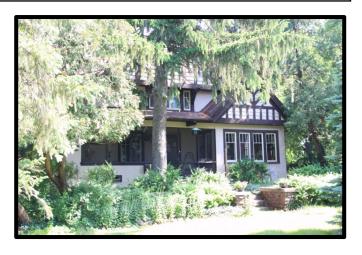
Condition: Excellent

Integrity: Excellent

Porch screened

Architectural Style: Tudor Revival

Ornamentation: 1/2 timbering, carved features

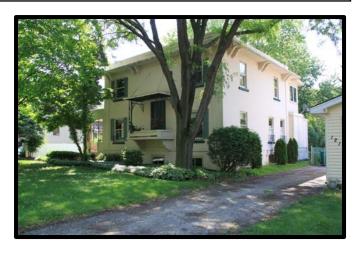
Condition: Excellent

Integrity: Good

Windows replaced; concrete painted; shutters added;

wrought iron added

Unique construction material and type, example of a Morrill Moulds Corporation concrete house

Current Wall Materials: Concrete

Concrete construction, eaves and parapet

Ralph Burrell was a mechanic & took out 3 construction loans in 1913 to build his experimental house. It appears to be a Milton Morrill design & likely built using the Morrill concrete construction method & steel forms. Morrill had patented a form & construction system based on an invention by Thomas Edison. His system had extensive press in Chicago around 1911 when a neighborhood of concrete houses was built in Gary, IN. Burrell died by 1917 & his wife sold the house in 1923. From 1934-67, the house was owned by E. George Goddard, a noted electrical engineer.

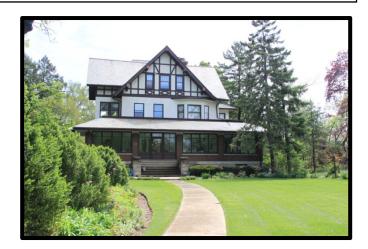
Condition: Excellent

Integrity: Excellent

Porch enclosed, barn altered to a one story garage after a

1962 fire destroyed the upper floors

Outstanding example of the Tudor Revival style with excellent integrity

Large porch & porte cochere; 1/2 timber framed exterior; bay window; roof brackets; extensive landscape

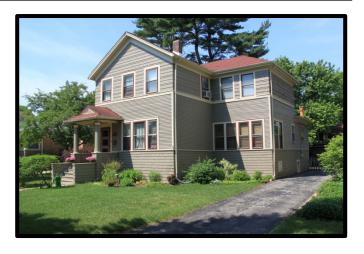
Condition: Excellent

Integrity: Poor

Moved in 1927; side & rear additions, shingle siding added, a Craftsman style character has been added (unsure if these character changes were done in 1927 or more recently)

Architectural Style: Craftsman (currently)

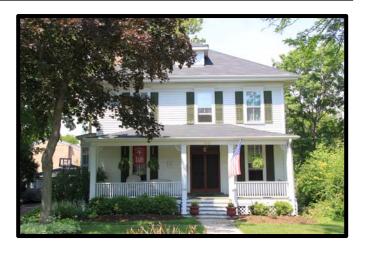
Condition: Excellent

Integrity: Excellent

Rear addition; porch modified or rebuilt; original tower

removed

Architectural Style: Italianate

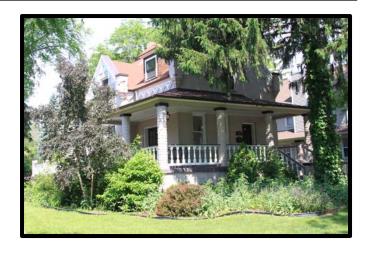
Condition: Good

Integrity: Excellent

Brick painted; rear addition

Architectural Style: Tudor Revival

Ornamentation: Brick corbels & parapets

Karl Geiersbach was a German brick mason. He built the house using local Hammerschmidt Brick & added a rear addition in 1930. He sold the house to Herbert & Mata Hover about 1935.

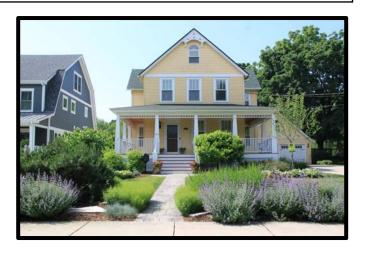
Condition: Excellent

Integrity: Good

Resided; rear addition; porch rebuilt; windows replaced

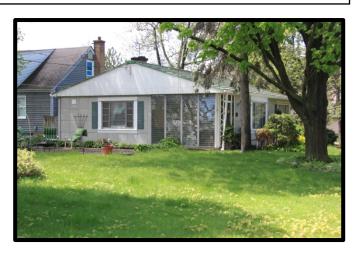
Excellent example of the pre-fabricated Lustron

House

Architectural Style: Mid-Century Modern

This is a Lustron Corporation metal house. It is the Westchester Delux, 2 bedroom model with serial number 2047 in gray. This model was the most popular of all Lustron models. The Delux included a bay window as well as several interior extras.
